# INSPECTION REPORT PREPURCHASE

134, du Barrage  
Terrebonne, (Québec) J2H 2M3

File: 2015000000

Done: July 29, 2015

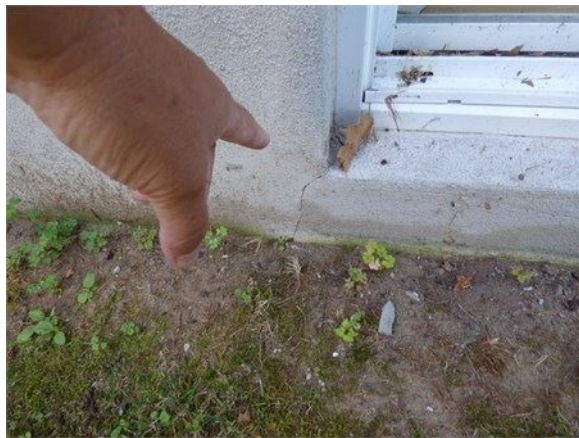
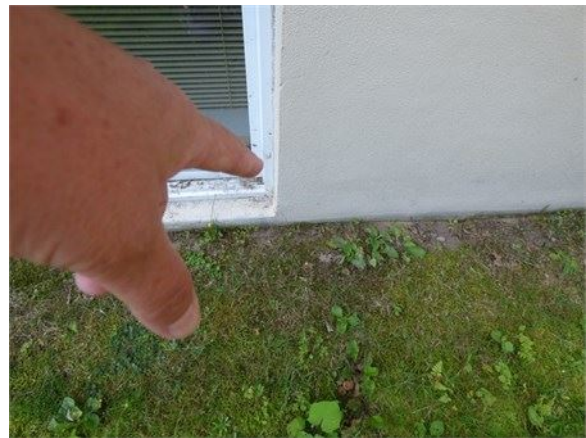
Cracks noted on the foundation walls. These cracks may represent water infiltration, and should be repaired to avoid water infiltration into the basement. Consult a licensed contractor to further evaluate and correct as needed.

Concrete - Minor fissures to be repaired ( less than1 mm )

The cement parging is damaged in certain areas. We recommend it be repaired in order to protect the foundation's concrete. For a better adherence, you may use concrete glue on the foundation, before applying the cement parging. Maintenance is required as soon as any damage is visible. This is to prevent water infiltration during the freezing and thawing periods.

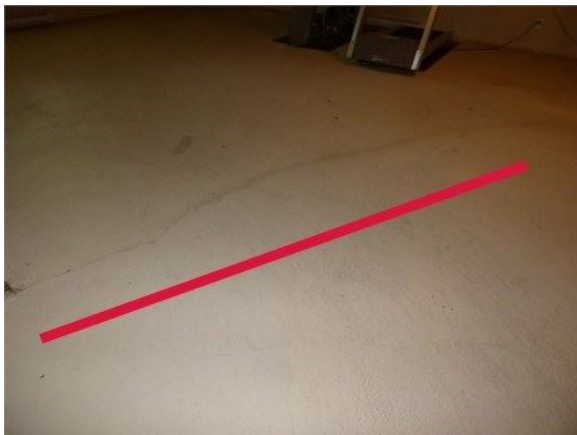
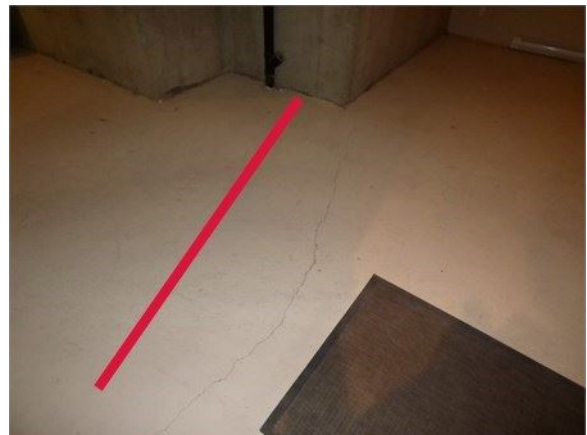
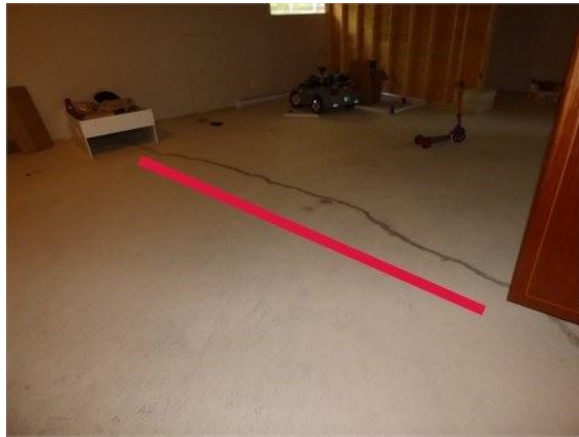
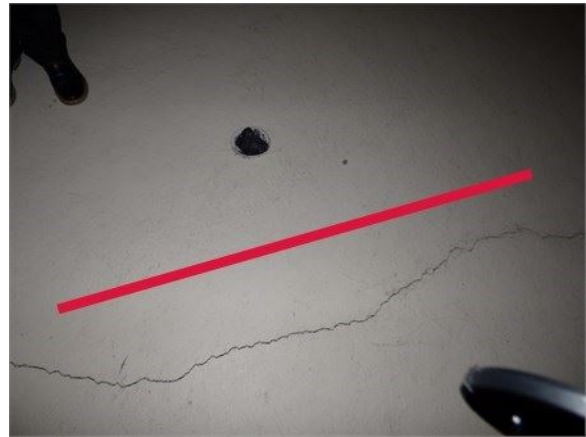
We noted some cracks in the basement's concrete slab. In our opinion, these were caused because control joints were not installed when the slab was poured. These cracks could be shrinkage cracks (which appeared while the concrete was drying) or they could have been caused by a slight settling of the soil beneath the slab. We recommend sealing the cracks.

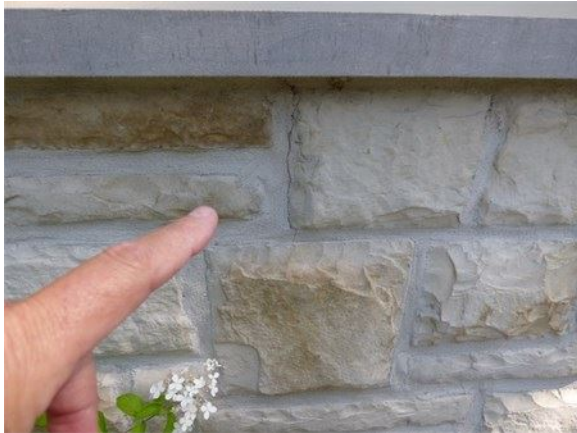
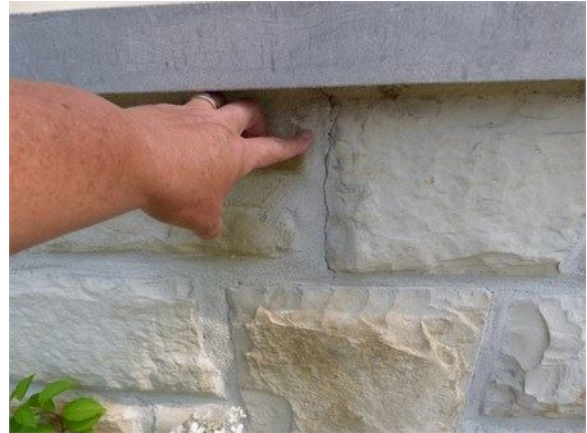
Damaged walls noted. Correct this condition as soon as possible. Consult a licensed masonry contractor to correct this condition.

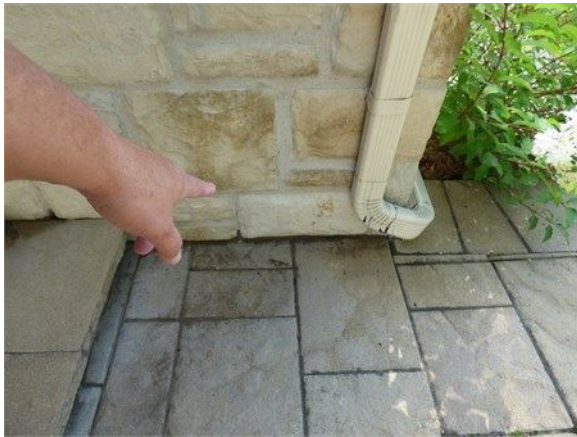
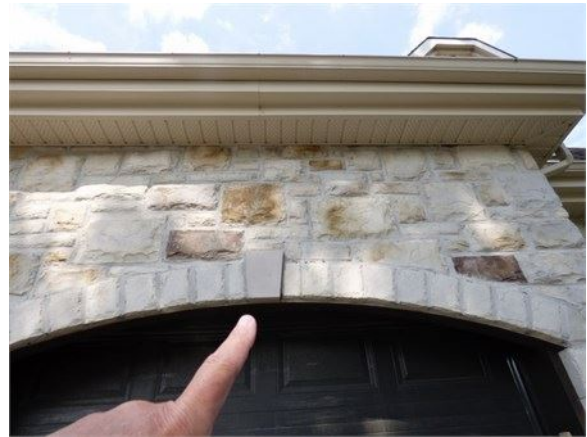
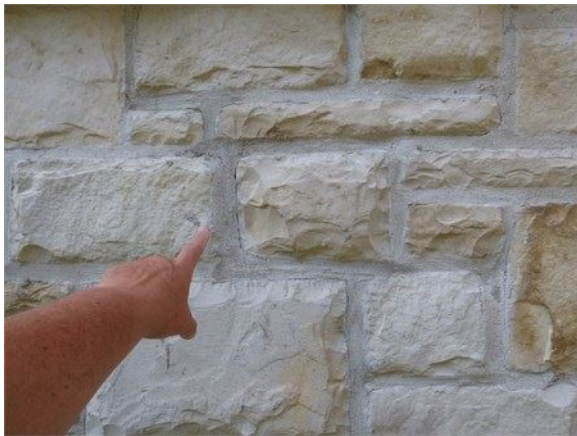
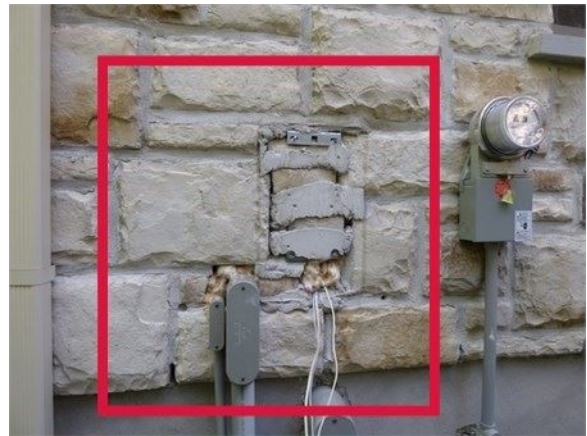
Monitor small cracks.

Repair damaged wall as soon as possible.

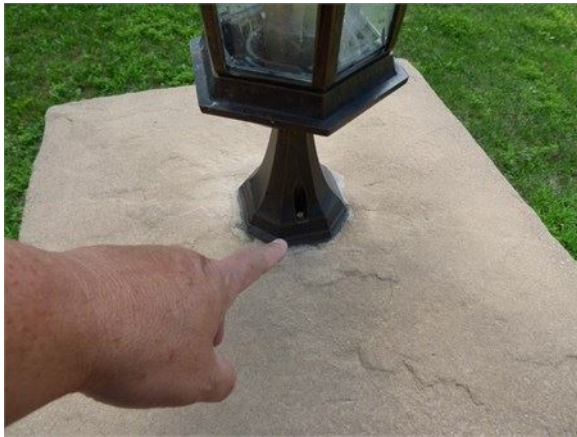
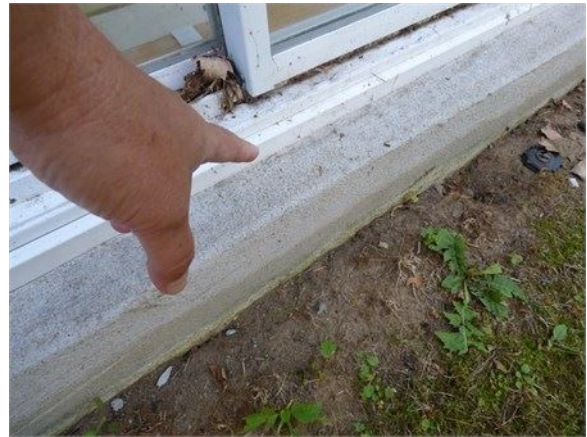
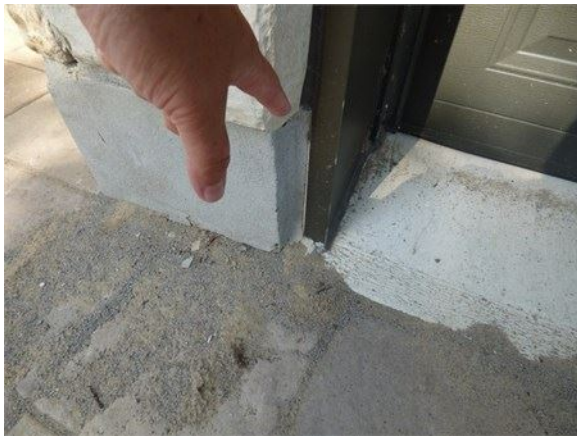
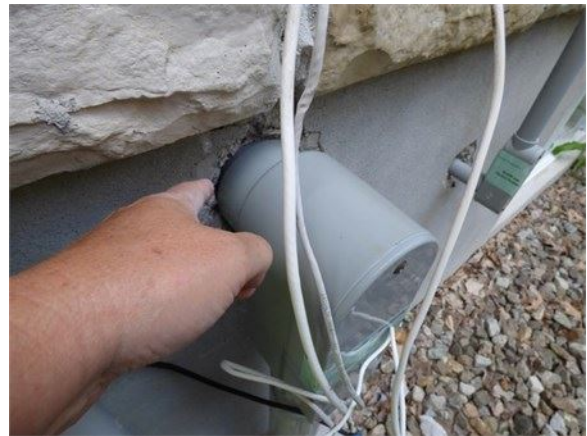
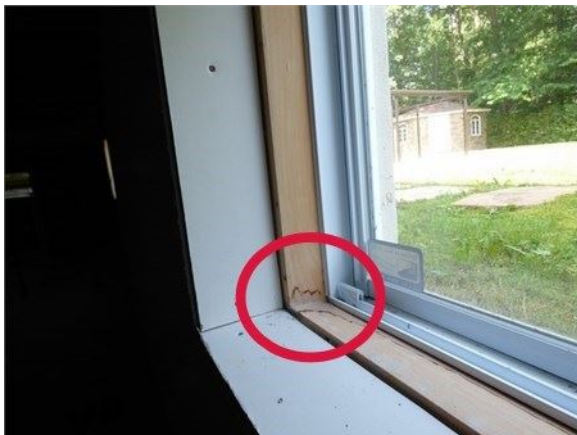
The sealant joints have deteriorated in some places and need to be redone. We recommend you check the condition of the seals every year to prevent water infiltration within the building's envelope and the deterioration of internal components.

Water leak noted

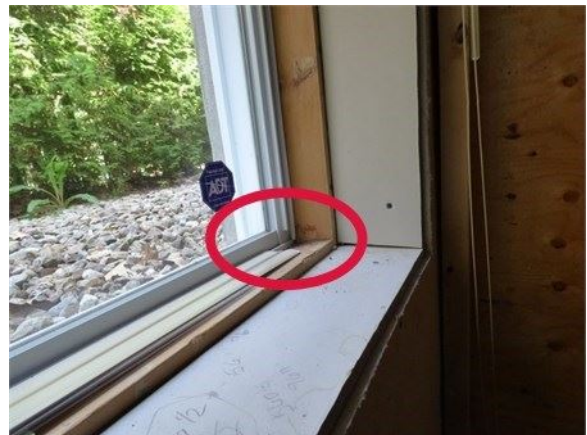
Water leak noted

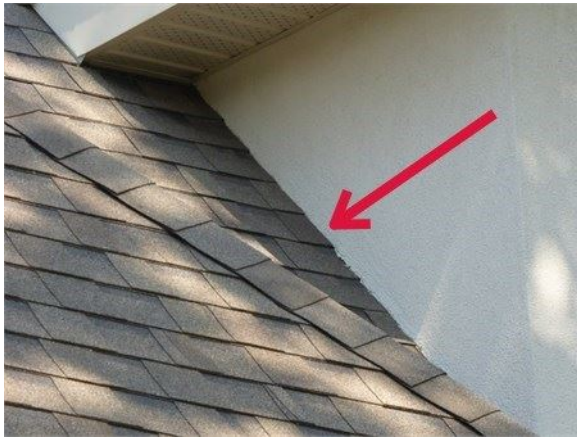
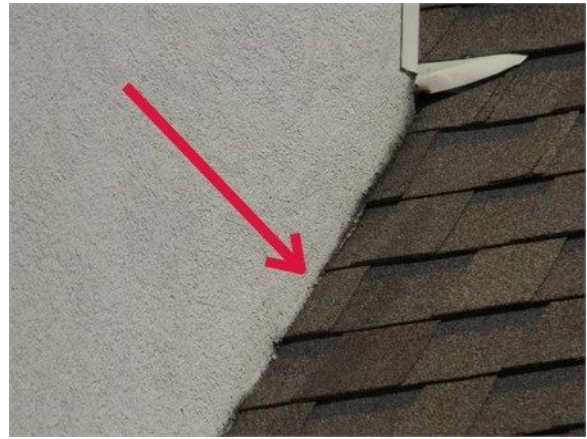
We do not see any flashings. We do not know if there are any.

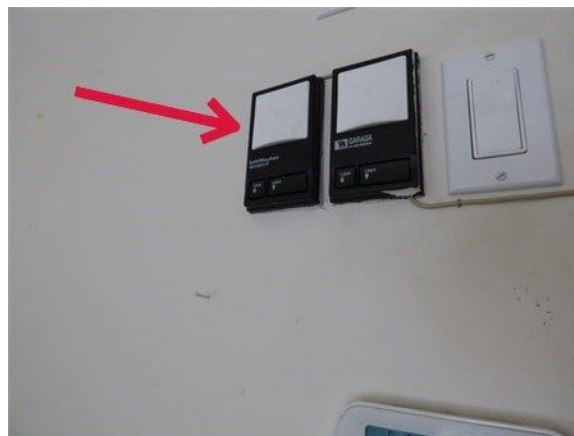
We note that the mechanism for opening the garage door is defective. Correct this condition.

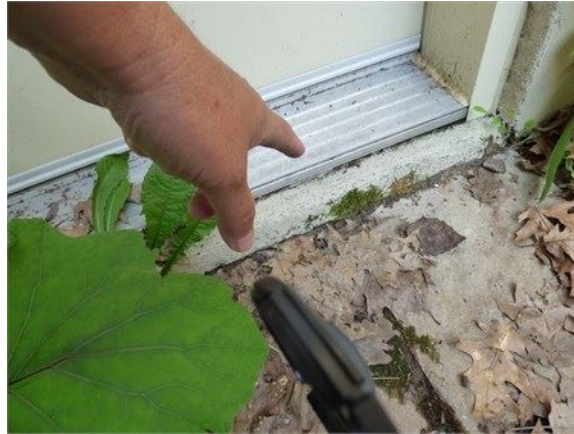
We noted that the caulking between the doorjamb and the threshold is deteriorated. Some of the doorjamb has started to deteriorate (rot). Repairs must be started as soon as possible.

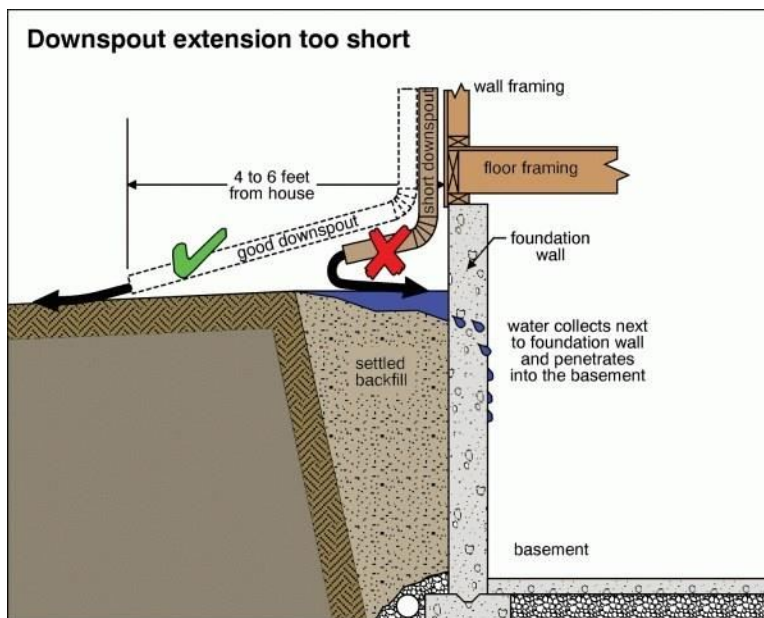
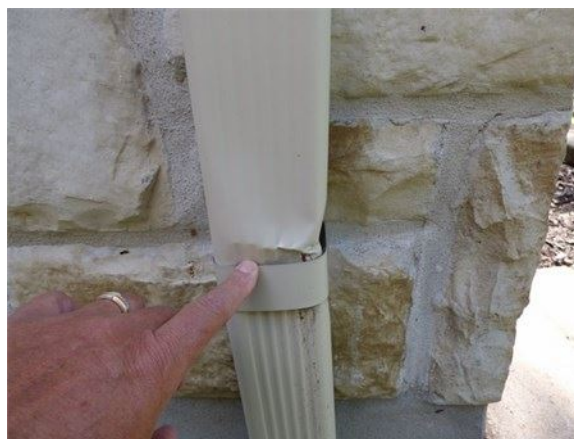
Replace damaged downspout

To avoid overloading the foundation drainage system, and to reduce the risk of water infiltration and excessive humidity in the basement, we recommend that downspouts direct water away from the house through the use of extensions or deflection slabs as needed. Leave 7 to 8 inches of space to avoid damage caused by winter ice and freezing. Eaves troughs should be inspected regularly (use a garden hose) and cleaned at least once each year (in the fall). If there are many trees in the area, it may be necessary to clean them more often.

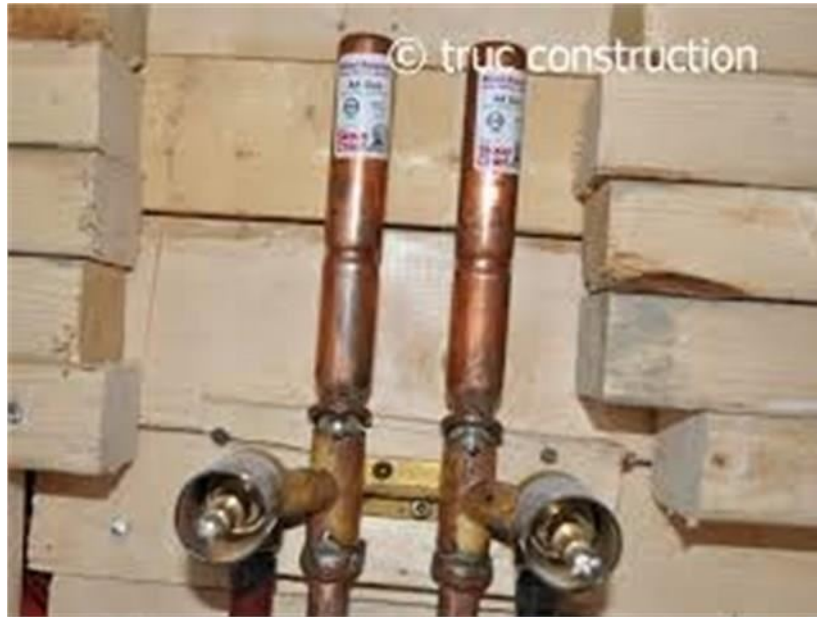
We note that the waste water drainage system is secured with inadequate clamps and supports. Appropriate clamps and supports should be installed to avoid damage and/or obstruction due to a collapsed water line.

Missing Air compression chambers . Knocking pipes occur because the water supply pipes in your home are under pressure. This is required so your plumbing system can function. In addition to the pipes that carry the water, there are air chambers built into the pipes that cushion the pressure when you turn on the faucet. The knocking occurs when the air in the pipes naturally depletes. When you turn on the faucet without the normal amount of air in the pockets, the water slams into the air or the end of the pipe, producing the dreaded knocking sound.

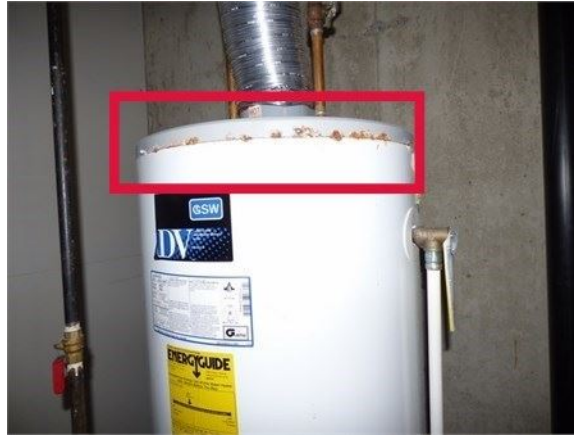
We note that the hot water heater is showing evident signs of aging. To avoid serious water damage, we suggest that you plan to replace it without delay.

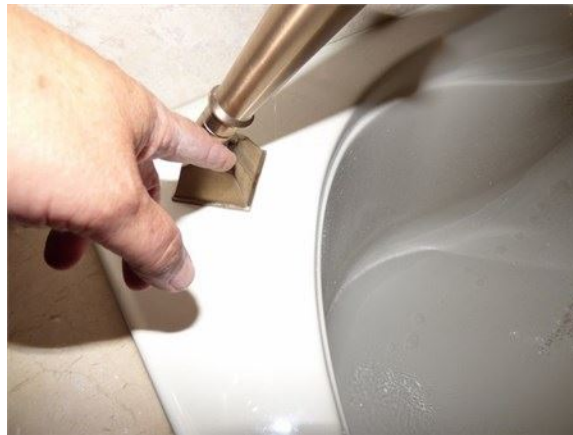
We note that some of the faucets leak. In time, leaky faucets waste a great amount of water. The washers of leaky faucets should be replaced.

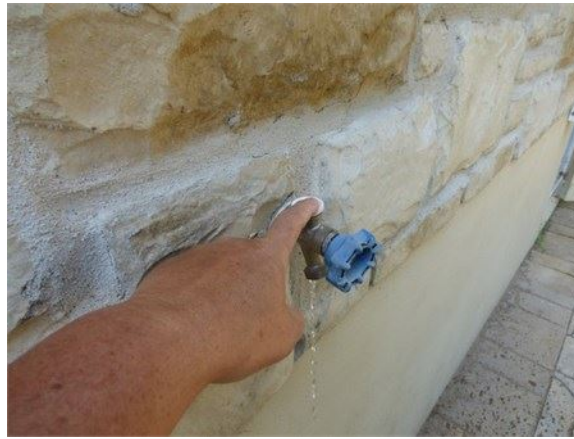
Exterior valve is not functioning properly . Recommend review by a licensed plumber.

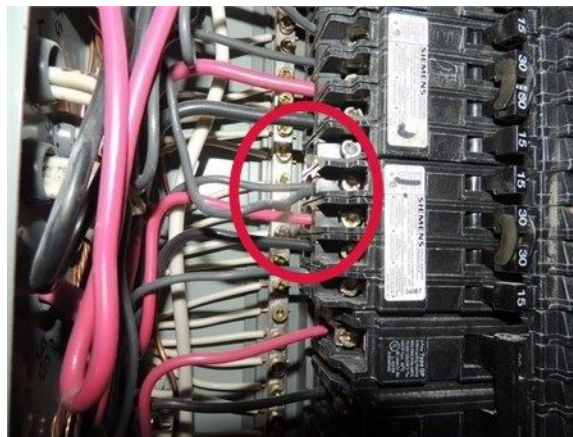
Doubled-up circuitry noted. This condition can add to the load of the affected electrical circuits, causing possible overload and tripping of the breakers. Ideally, each circuit should be independently fused. We recommend this condition be corrected.

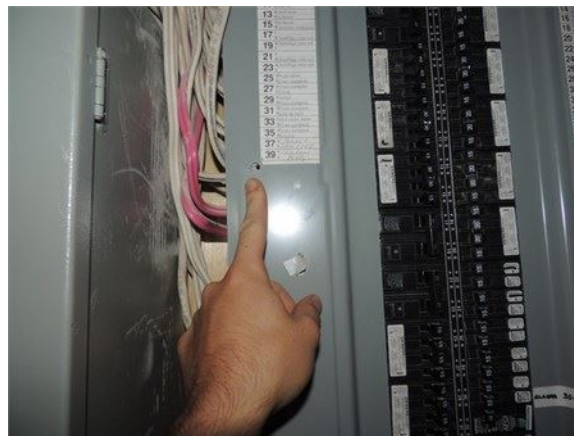
Missing electrical screws. Correct this situation.

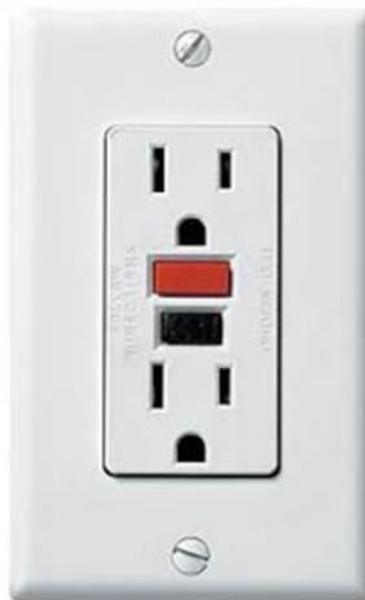
Outlets without Ground Fault Interrupters (GFIC) noted. It is recommended that outlets near water sources, such as exterior outlets, garage, kitchen and bathrooms, be equipped with GFIs. We recommend, for safety reasons, this be corrected.

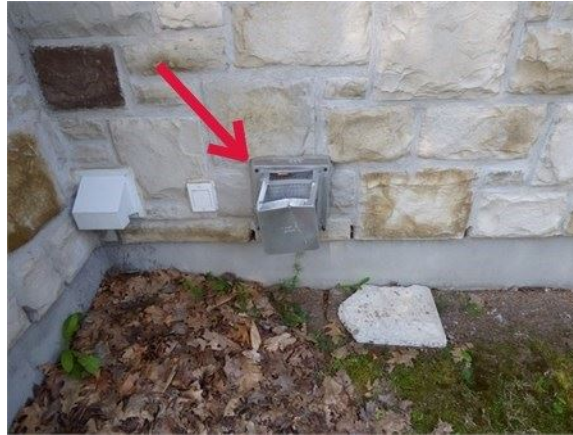
Damaged hot vent. Replacement required.

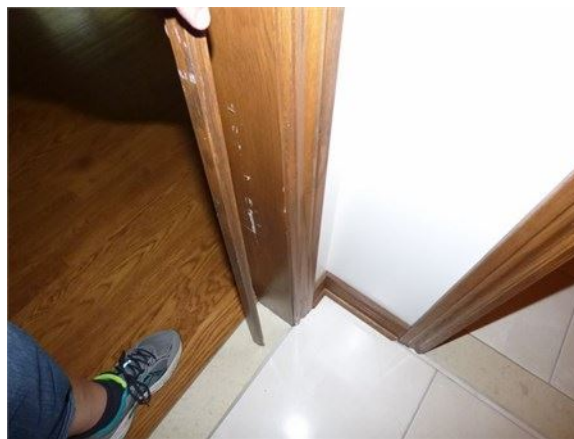
Frame is damaged. Repairs are needed.

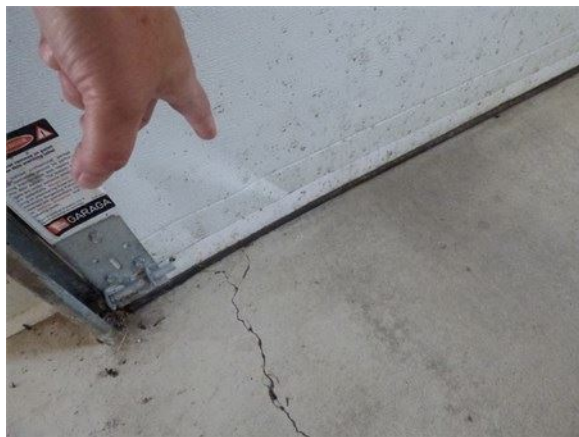
Cracks noted

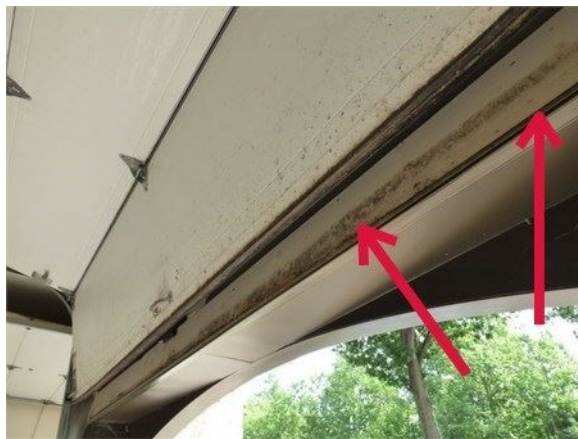
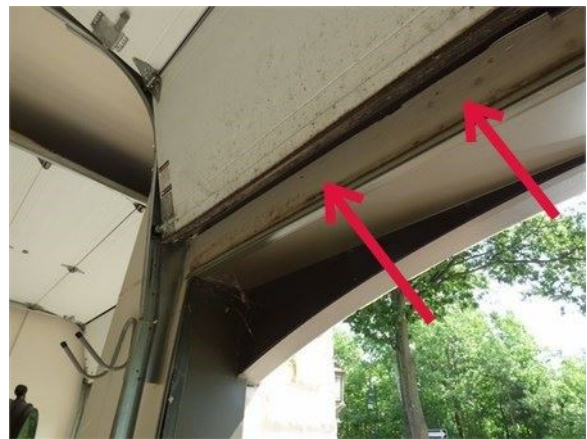
We detected a slight odour of mould and humidity in the cold room and garage. Mould is a health hazard and must therefore be decontamination or removed. We recommend the area be well inspected in order to detect all traces of excessive mould and humidity. Make sure the area is properly ventilated and repair water infiltrations. If the problem persists, an expert analysis should be done.

Signs of water infiltration

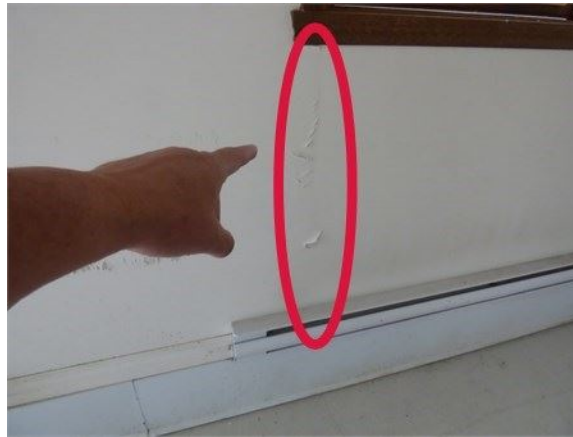
We observed signs of water infiltration in the garage (beneath window). You should determine the exact origin of these infiltrations and take appropriate corrective action to avoid rapid deterioration of the internal components.

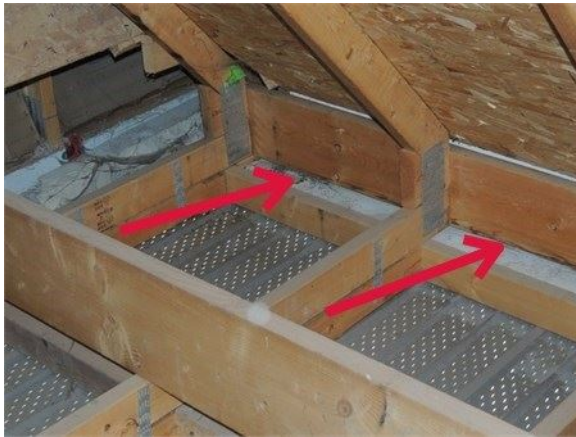
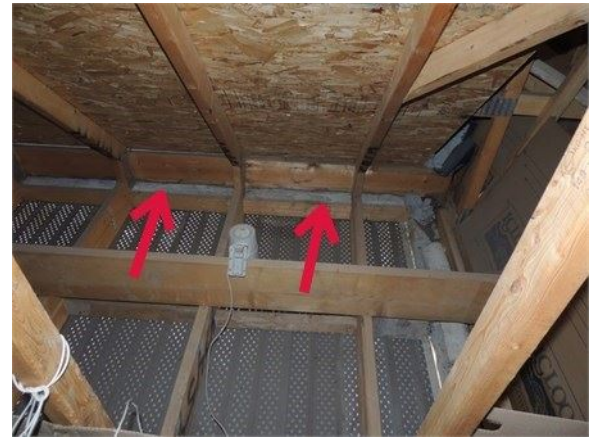
Traces of water infiltration noted in the attic. During our visit, attic space was dry. The inspector cannot determine when, in the past, the roof leaked. The attic space should be inspected regularly. If water infiltration was noted the origin of the leak should be determined and corrective action should be taken to fix the leaks, in order to avoid deterioration of the internal components.

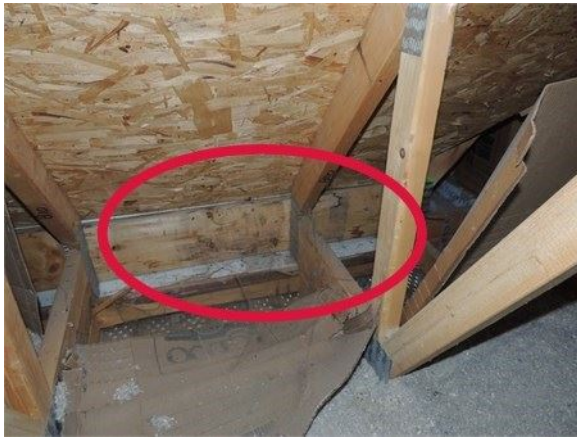
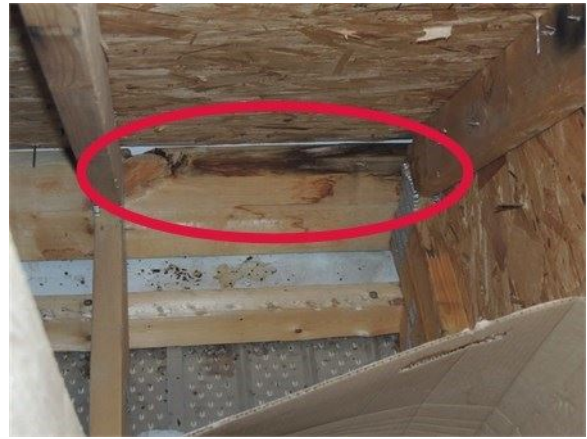
Possibly caused by snow and wind

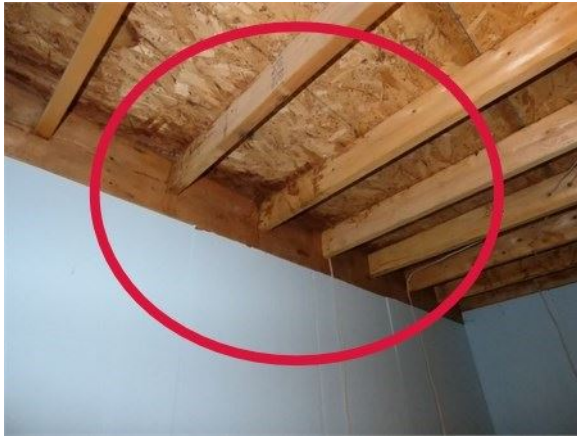
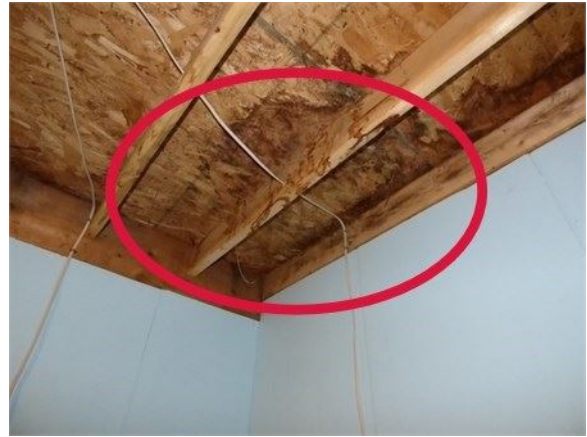
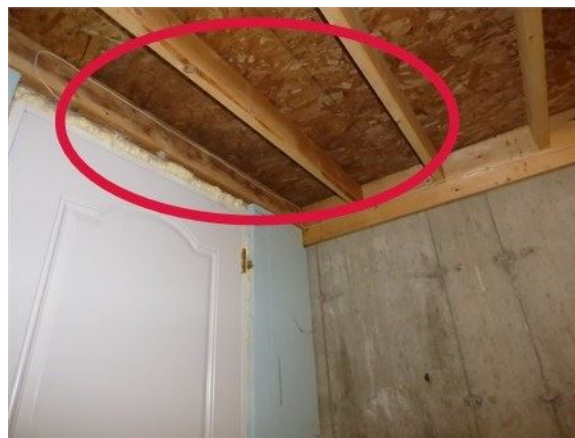
Cold room - Signs of previous water damage noted. Dry at time of inspection. We recommend repairs be performed.

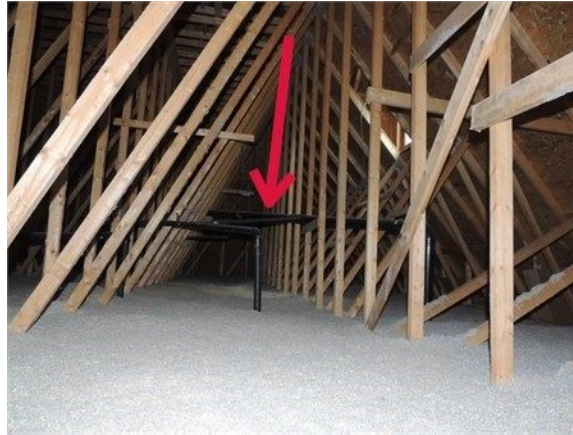
Uninsulated vent stack noted. It is recommended that the vent stack be insulated to prevent possible condensation. We recommend correcting this situation.

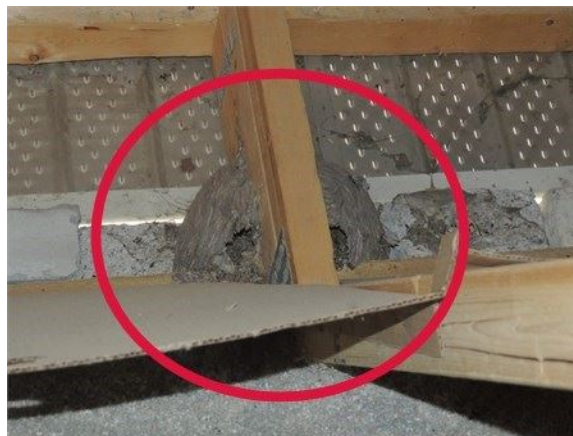
Sign of insects noted in the attic. Seal or install screens in all suspect areas. Consult an expert as necessary.
