# INSPECTION REPORT PREPURCHASE

134, du Barrage  
Terrebonne, (Québec) J2H 2M3

File: 2015000000

Done: July 29, 2015

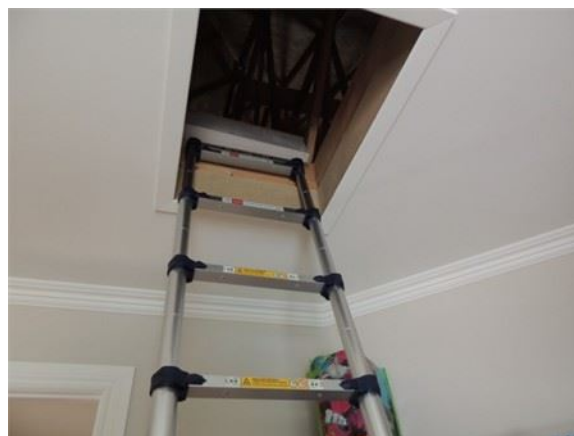
Viewed by entering attic through hatch.

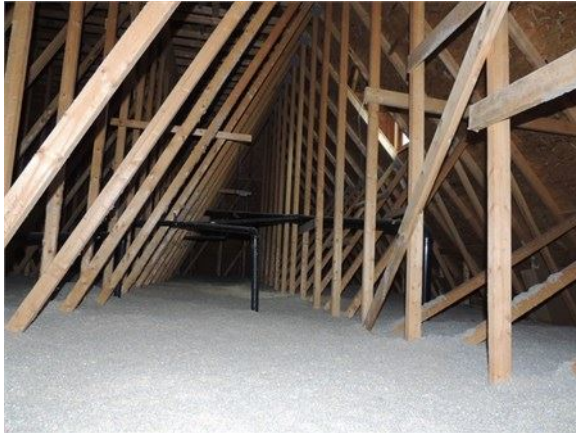
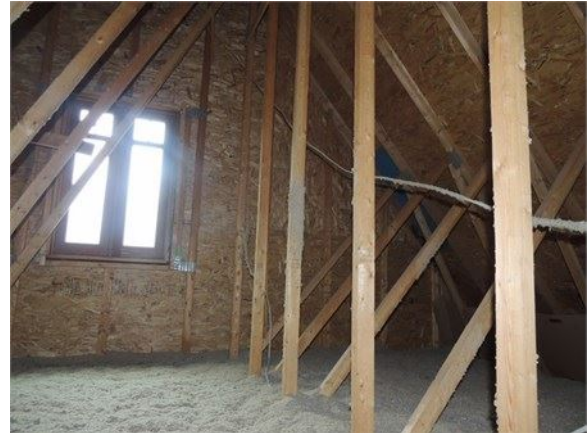
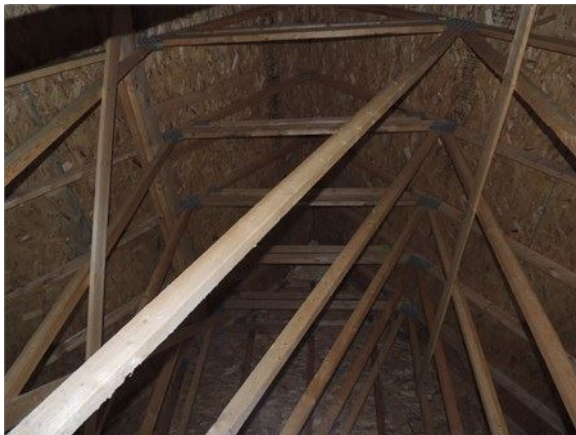
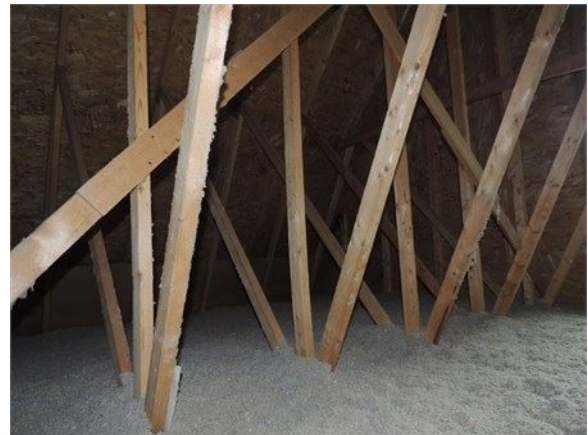
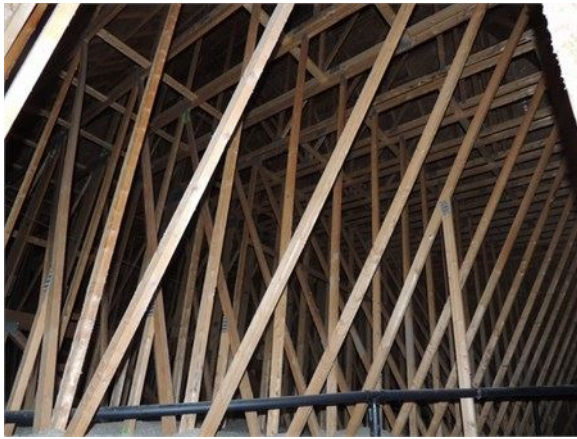
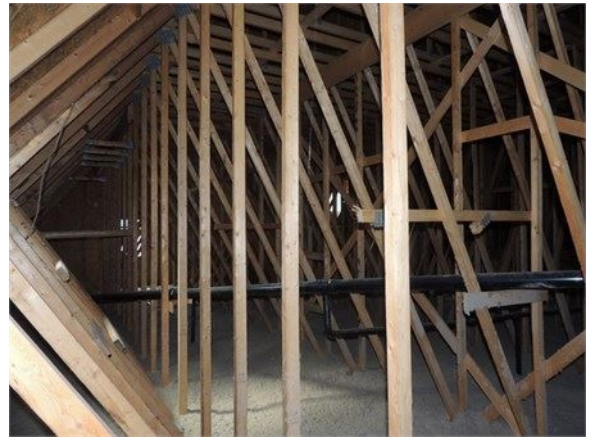
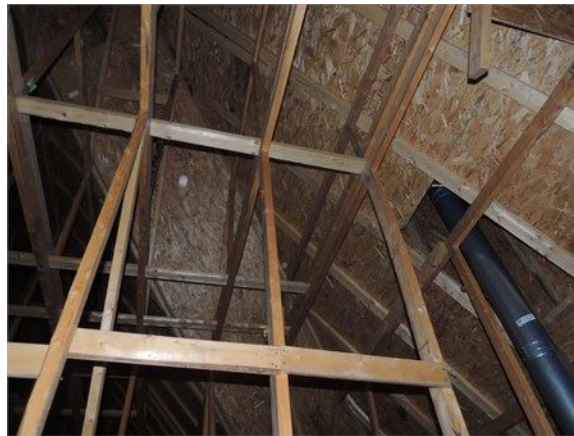
Usable, in general at time of inspection.

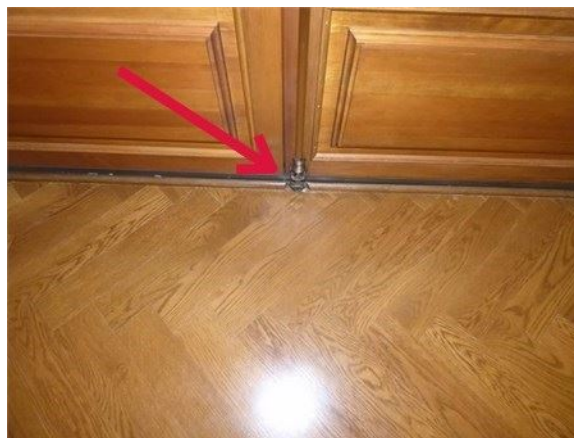
Operation of door is difficult. Adjustment required.

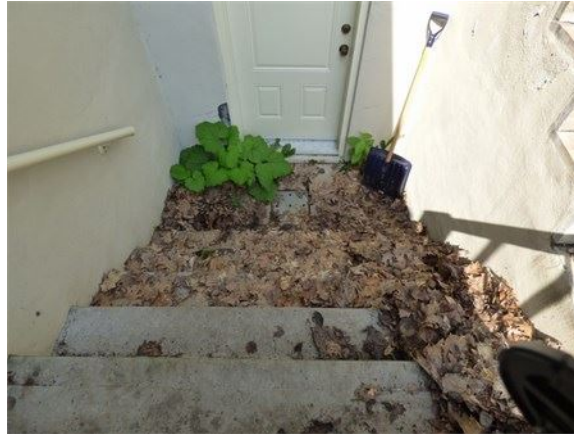
Acceptable, in general.

The outside drains should be cleaned and maintained to prevent serious problems of water infiltration within the building at times of heavy rains. Use a standard garden hose to verify normal water drainage. If needed, have a specialist clear the conduits.

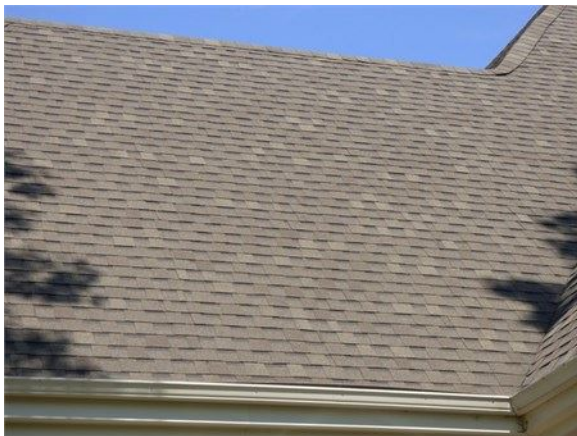
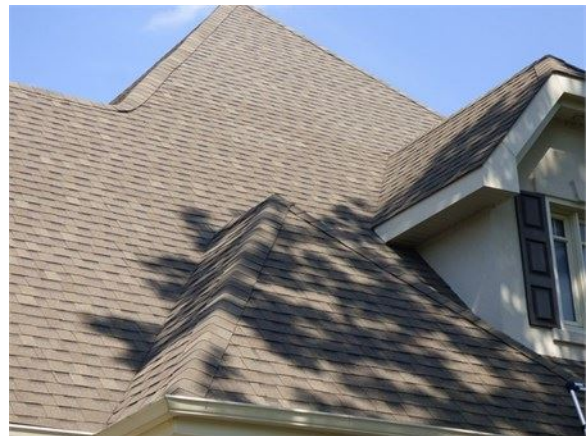
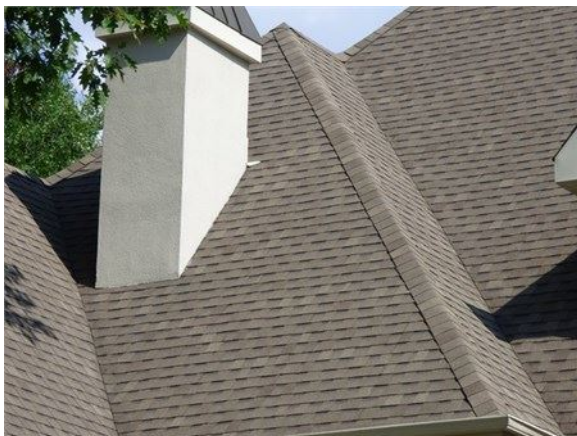
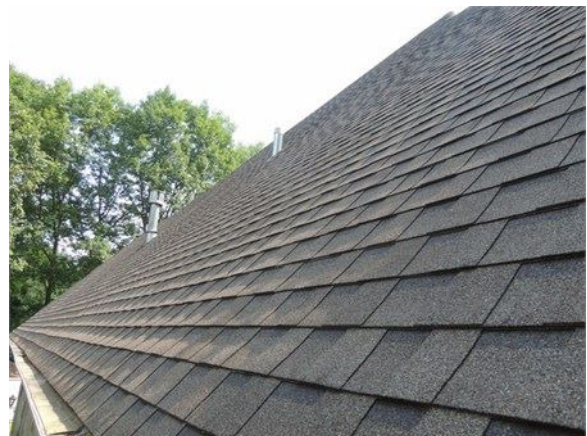
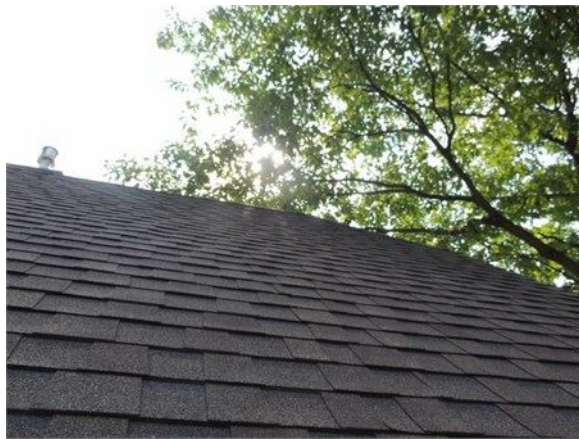
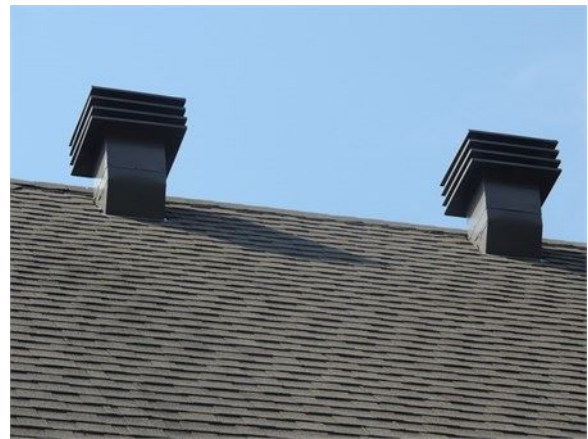
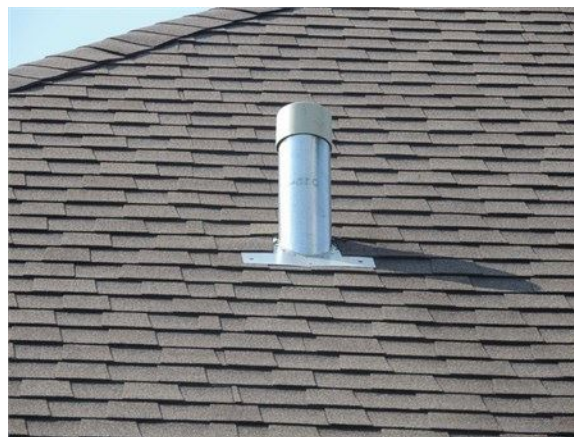
We recommend obtaining from the seller disclosure/invoice/guaranty concerning this condition.

Note: Typical life expectancy for roofing products can vary widely as a function of the material composition, type, installation details, and other factors discussed in depth at this website. Typical shingle life expectancies range from about 15 years to 40 years.

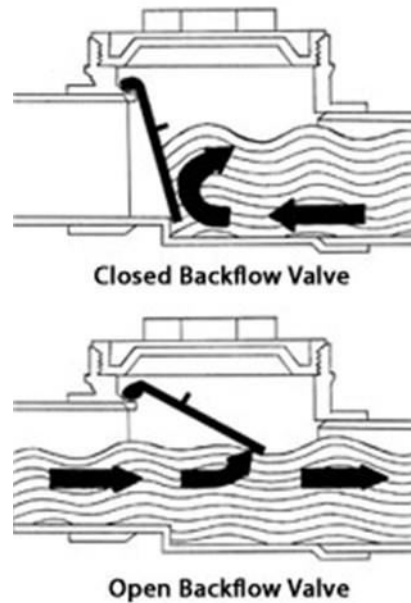
Backwater valve Present. This valve essentially prevents water from returning due to a back up of water in the sewers. As well, to avoid sewage backups it is important to ensure that there is a valve on the branches of the sinks, floor drains, toilettes and showers in the basement. These must be easily accessible to allow for maintenance (1 or 2 times each year).

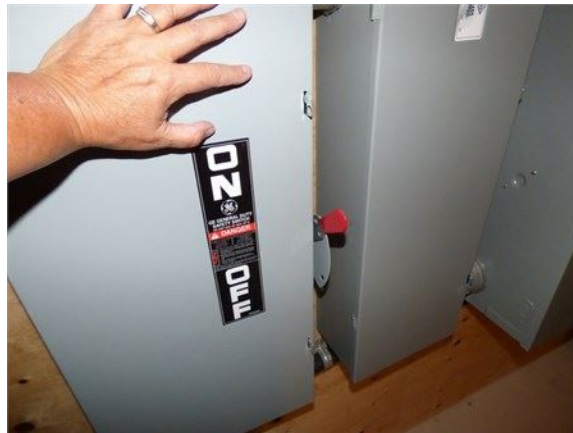
Main service box protective with circuit-breaker and location of box is at basement.

SAFETY WARNING: For safety reasons, we recommend locking the Main Service Panels.

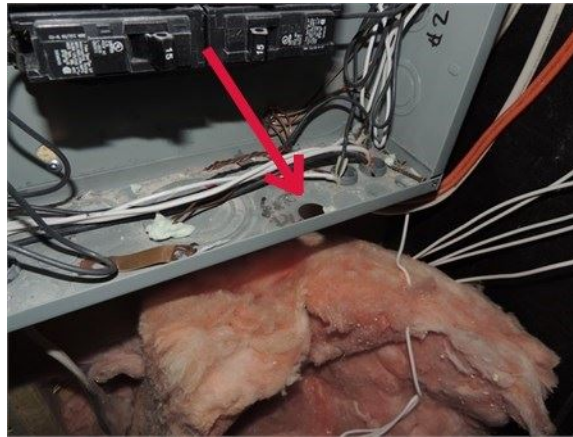
We note that there are a number of unsealed openings in the distribution panel. This may be a high-risk situation for occupant safety. This situation should be corrected by sealing all openings in the panel.

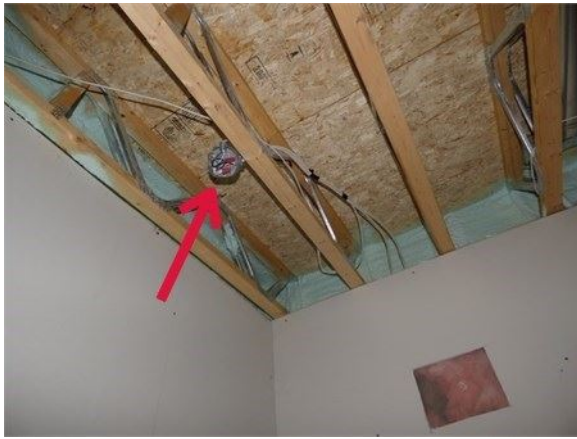
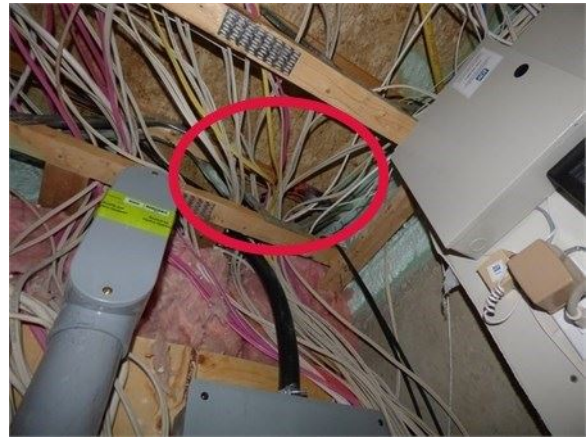
We note that some electric connections are not covered, which may be a high-risk situation for the safety of the building and its occupants. Electrical connections should be made with appropriate connectors based on the number and size of wires, and they should be located in an enclosed hexagonal box (as required). An electrical connection should not be concealed within a finished wall or ceiling and should be accessible.

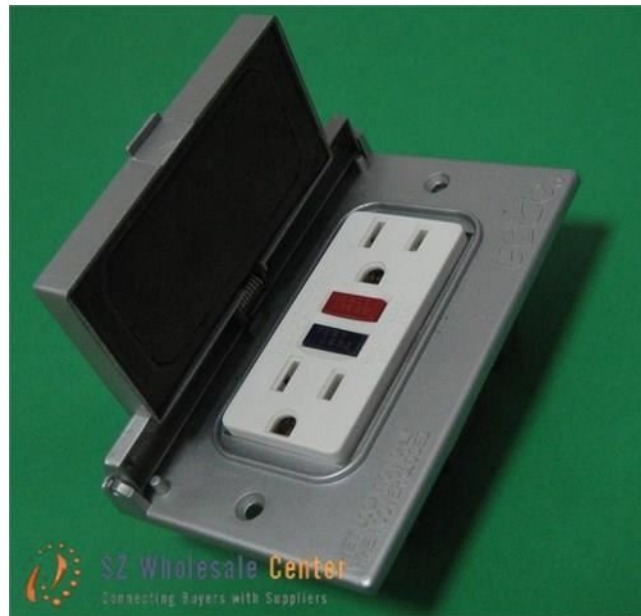
Outlets without Ground Fault Interrupters (GFIC) noted. It is recommended that outlets near water sources, such as exterior outlets, garage, kitchen and bathrooms, be equipped with GFIs. We recommend, for safety reasons, this be corrected.

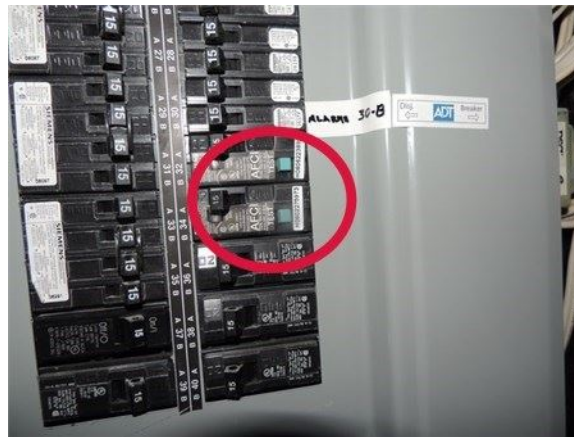
ARC FAULT present. AFCIs should be tested once a month to make sure they are working properly and providing protection from fires initiated by arcing faults.

A test button is located on the front of the device. The user should follow the instructions accompanying the device. If the device does not trip when tested, the AFCI is defective and should be replaced.

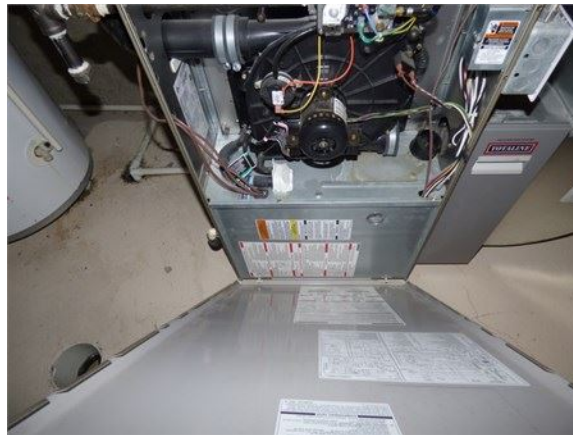
The furnace was not tested because the air conditioning was in operation at the time of the inspection and the outside temperature was too high. Prior to operating the heating system, we recommend the complete system be fully reviewed by a heating specialist to ensure proper and safe operation of the system.

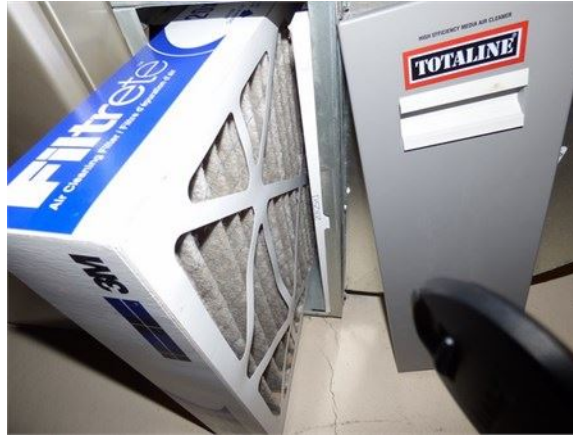
Air filter in good condition.

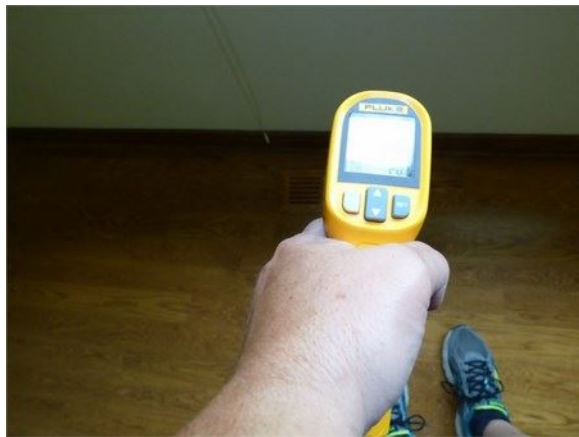
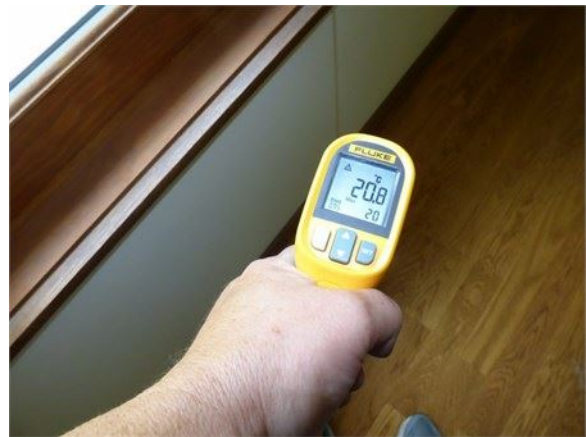
Located: condenser located at left side.

The air conditioning unit was activated to check the operation of the motor and the compressor, both of which appear to be in serviceable condition. A detailed review of the cooling capacity of this unit is beyond the scope of this inspection. We recommend consulting a specialist for a complete review of the system.

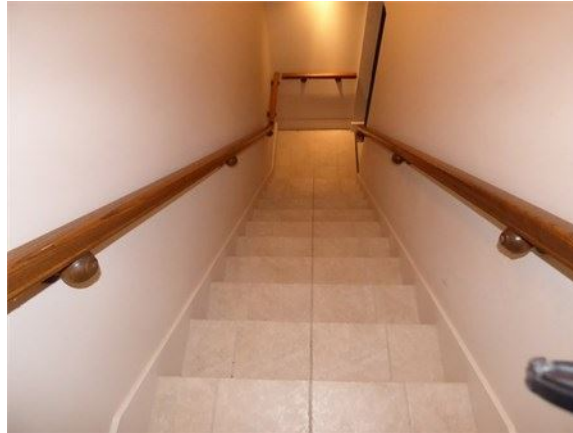
We note that there is a very steep interior stairway, which could be dangerous for the safety of the occupants. If the situation cannot be corrected by a carpenter, we advise you to ensure that an antiskid surface be provided for the treads, that the stairwell lighting be adequate, and that the stairway be equipped with a safe and solid handrail.

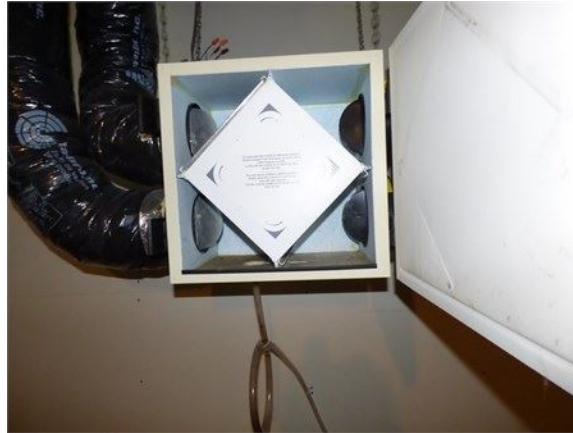
Access Panel was opened. A detailed review of the exchanging capacity of this unit is beyond the scope

of this inspection. We recommend consulting a specialist for a complete review of the system.
